第一部 海鷹丸航海調査報告 平成11年度  
第75次航海報告

ヌメア港（ニューカレドニア）・スバ港（フィジー）入港報告

Report of Noumea Port and Suva Port

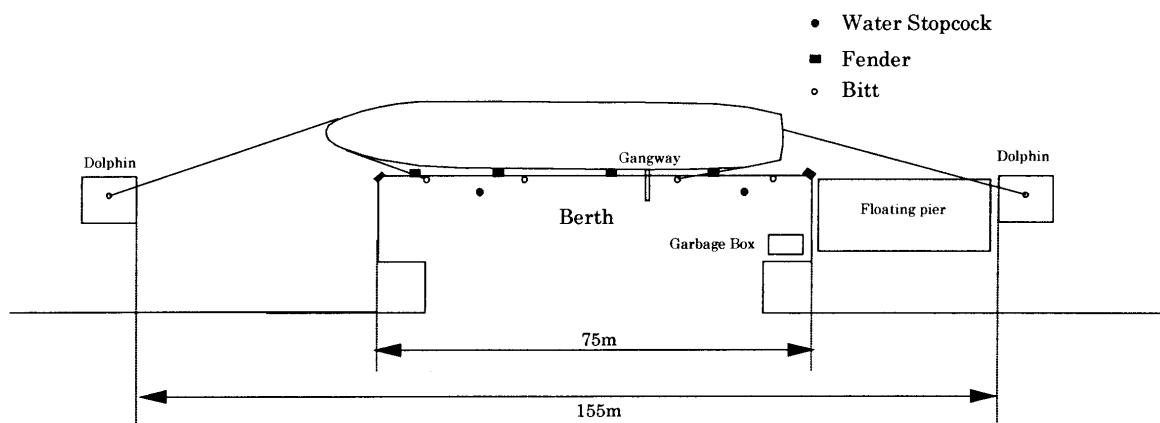
Fig. 3. Tourist vessel wharf of outline.

本船が着岸した岸壁は、Old Passenger Cruse Wharf (海図上では Quai FED と記載)である。岸壁の全長は 75m で前後に繫留柱がある。岸壁の側壁には黒色ゴム製のフェンダー (直径 1m、長さ 1.5m) がほぼ等間隔に 5 箇所設置されている。設置位置は岸壁上端から 1m ほどの長さの鎖によって吊るされている(Photo 6)。ビットは岸壁に 4 箇所、繫留柱にそれぞれ 1 箇所設置されている。本船繫留時はヘッドライン、スタンラインを繫留柱のビットに、スプリングラインは岸壁のビットに取った(Photo 7,8)。岸壁はコンクリートとアスファルトで出来ており凹凸はない(Photo 9)。また、岸壁に入口にはゲートのようなものは一切ない。

10:50      Brun 島山頂      方位 077 度距離 0.3NM  
11:16      ヌメア港 FED 栈橋に着岸(Fig.3.)

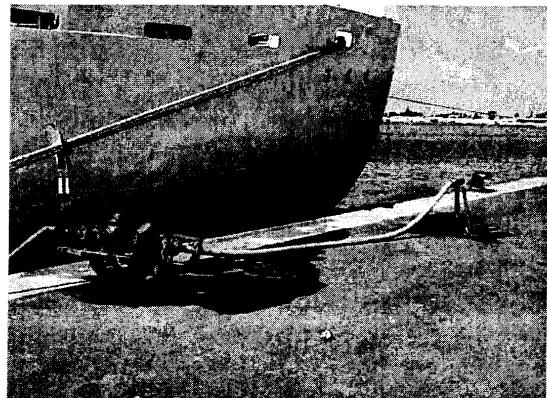
Photo 10. Water supplying work.

本船が着岸した岸壁には2ヶ所の給水栓がある。1日目は船首側の給水栓を使用し、給水ホースの直径は約3cmと細いため本船で所持している分配器、ホースなどは使用しなかった(Photo 10)。また、給水量は1時間当たり5tほどであった。2日目は船尾側の給水栓を使用した。給水ホースの直径は約7cmで1時間当たりの給水量は約20tである。Guide to port entryによれば約40t積み込めるように記載されていたが記載事項とは異なっていた。現地在住の日本人によれば水質は良好で水道水を飲用しても問題はないと言ふことである。本港では雑用水、飲料水ともに補給した。

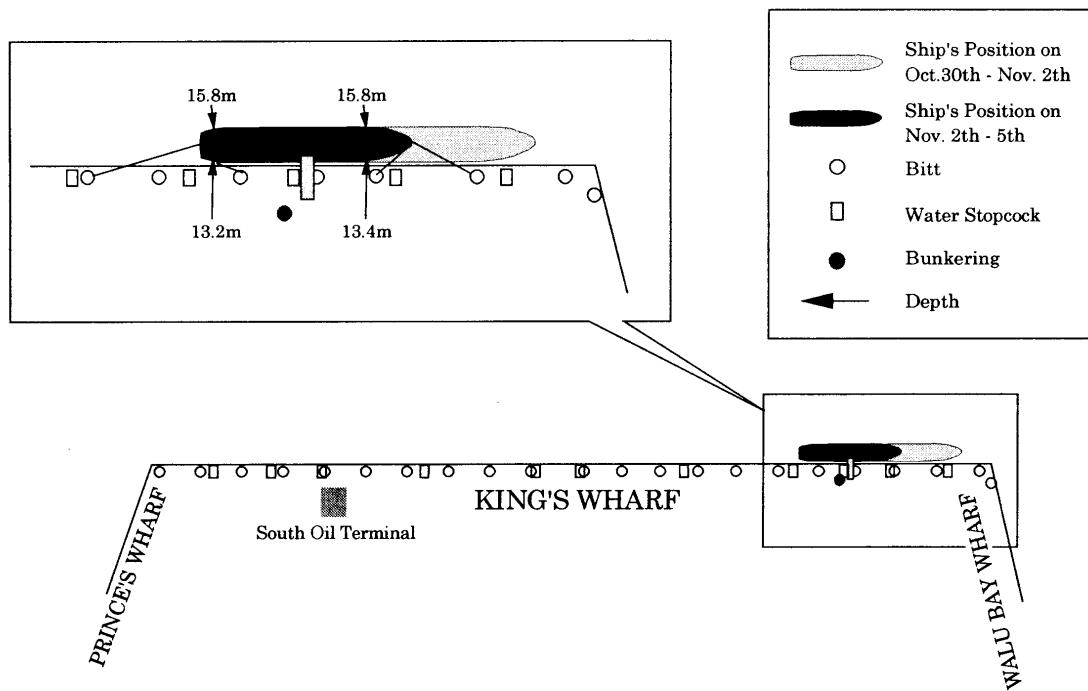
Fig. 1. Outline of Suva harbor.

Suva は、Fiji の首都である。岸壁は、南北方向にのびる全長 459m の KING'S WHARF と、その南側に位置する Prince's Wharf と北側に位置する Walu Bay Wharf (183m) がある (Fig. 1)。岸壁はコンクリート製で、凹凸は少なく平らである。タラップの設置は、ビットの位置を避けねば、敷板等は必要ない。ただし、Prince's Wharf については、岸壁が途中で坂になっている箇所がある。

フェンダーは、黒のゴム製で、約 9~10m の間隔で設置されている。フェンダーは、破損すると、その都度交換するようで、状態は良好である。本船着岸の際には、岸壁のフェンダーが直接船体に当らないように、用意したフェンダーを間に入れた (Photo. 7)。ピットは、ほぼ等間隔に 27m くらいの間隔で設置されている (Fig. 1)。

給油施設は、KING'S WHARF の南側 South Oil Terminal と、岸壁北端から 90m の地点にある (Fig. 1)。本船は北側にある給油口から給油を行なった (Photos 9,10)。この給油口からの供給量は時間 80kl と言う事であったが、実際には約 100kl であった。

給水は、いずれの岸壁で可能である。本船の着岸した KING'S WHARF 北端には、約 25m 間隔に水栓があり、位置的な問題は無かった (Fig. 1)。本船では、2ヶ所の水栓から船尾側の飲料水タンクと船首側の雑用水タンクに補給を行なった。供給量は、いずれの水栓からも時間 20t~30t であった。問題点としては、業者が持ってくるホースが傷んでいるため、ホースからの漏水が多い事である (Photo. 11,12)。作業が終了した後、VHFCh12 (呼出: Port Control) でその旨を伝えると、ホースとメーターを回収に来る。

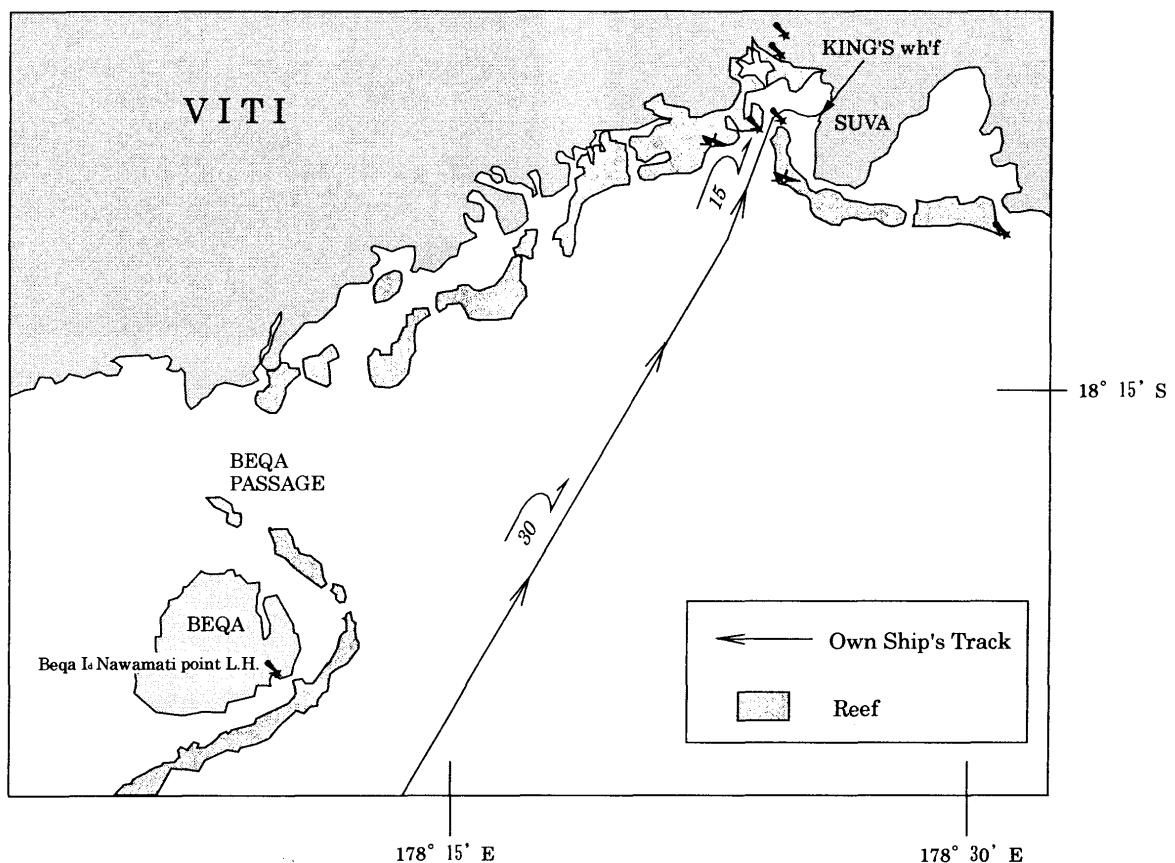
Fig. 2. Outline of the approach track.

01:15 Naurabuta Lt. b'g on 27° dist. 8.2 miles off.  
04:13 Beqe Island Nawamatipoint Lt. b'g on 27° dist. 14.2 miles off.  
06:00 Beqe Island Nawamatipoint Lt. b'g on 320° dist. 4.9 miles off.  
09:19 Old LH. tower b'g on 012° dist. 3.4 miles off.  
10:21 Suva harbour E Reef Nend b'y b'g on 095° dist. 0.2 miles off.  
11:00 Port of Suva KING'S wh'f
